## **EXHIBIT G**

**Investigation of the  
December 20, 2002  
Fire at The  
Marino Carriage House**

BN62867-A0T0-0306-R004

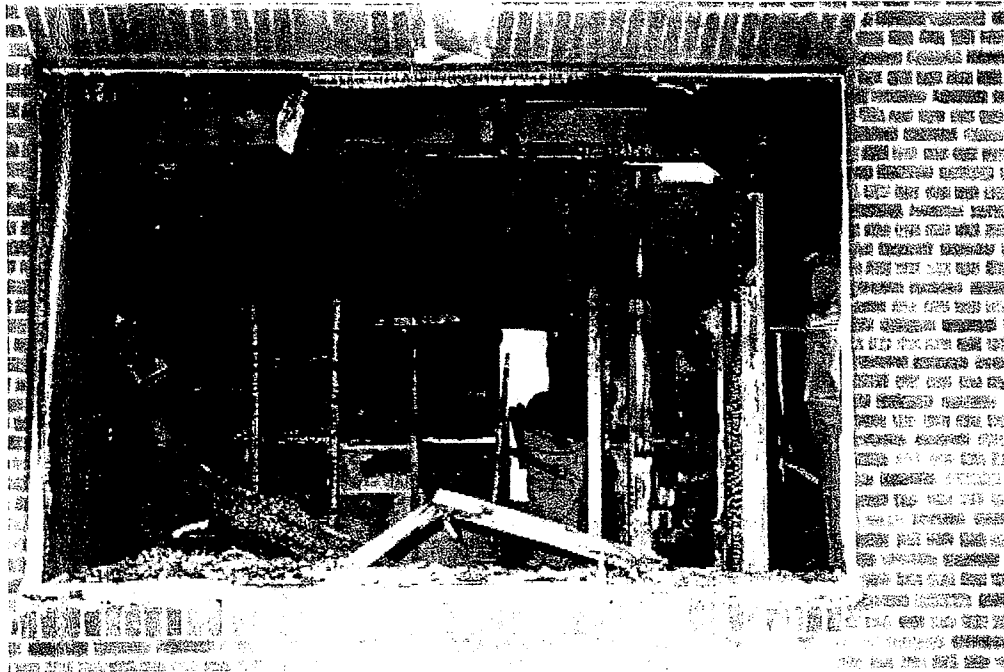
from the top down. At the end of the fire, the back wall of the kitchen across from the window was almost entirely consumed, as shown in Figure 14.

Figure 14: Post fire view into kitchen window.

Because heat and flames spread up and out, these photos suggest the fire originated on the first floor in a region slightly to the right of (north of) the center of the carriage house, *i.e.* towards the right (north side) of the foyer and towards the left (south side) of the kitchen. The initial photographs, however, show an intense fire located in the second floor. This indicates that the fire may have started on the second floor; with the stairway, foyer, and kitchen being subsequently ignited by drop-down of burning material from the second floor.

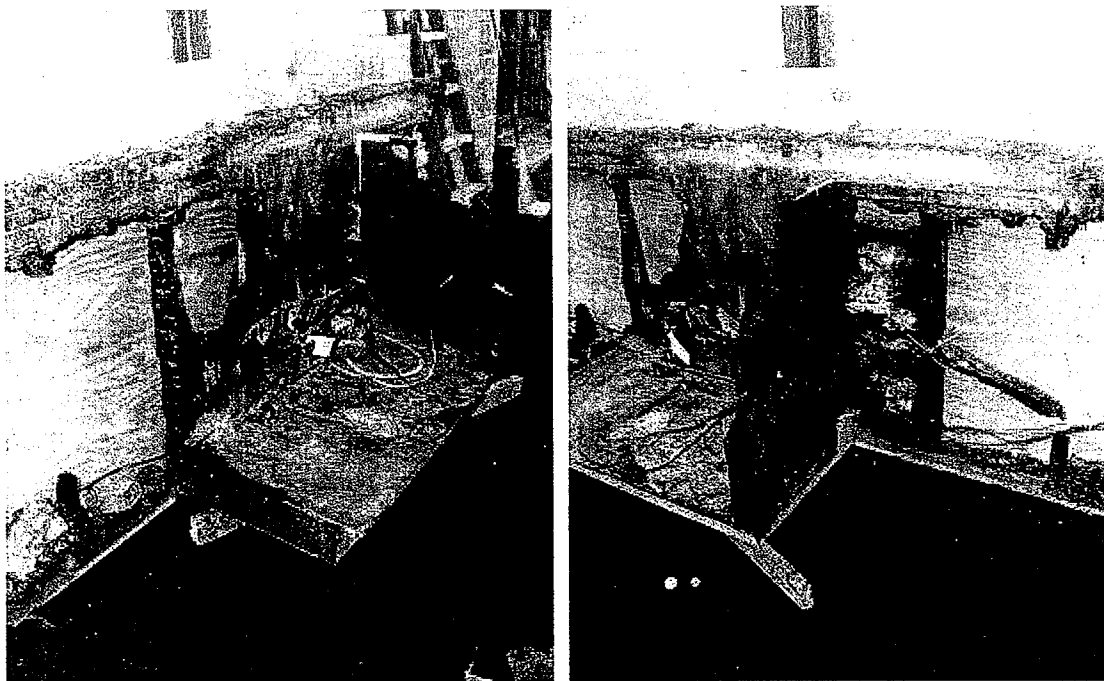
Additional photographs taken of the cabinets and wall after they were removed from the kitchen further demonstrate that they were attacked by fire from the outside. Two photographs taken from the north and south sides (left and right sides when looking out the front kitchen window) of the kitchen cabinet are shown in Figure 23. In each photo more significant fire damage is observed to both the left and the right of the cabinet than within the cabinet itself. As you move from the sink to either side, a greater extent of wood is consumed and deeper charring is present. This is further demonstrated in Figure 24, showing two photographs taken from either side of the wood cabinet wall between the sink and the dishwasher. Even though the dishwasher partially shielded the wood from fire, it has more significant charring on the outside of the cabinet (adjacent to the dishwasher) than the inside of the cabinet.

Figure 23: Photographs of sink cabinet looking from the left and the right. Fire damage to the wall structure and the cabinet is more severe outside of the cabinet than within the cabinet.

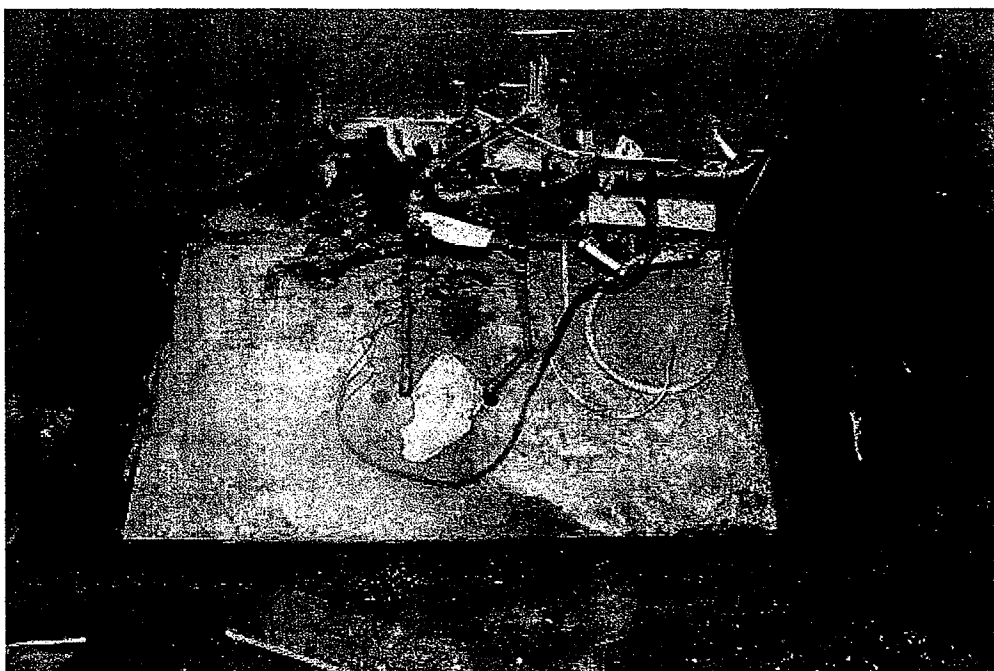
The floor of the kitchen sink cabinet is virtually undamaged as shown in Figure 25. Some fire damage is present in the right front of the cabinet, consistent with the cabinet being attacked from the exterior. A section of gray polymeric material is melted to the floor of the cabinet, between where the copper water pipes penetrate the bottom of the cabinet. It is consistent with sound deadening material that was applied to the bottom of the metal sink and fell to the floor of the cabinet as the sink was heated from above. Some discoloration or charring is visible to the floor of the cabinet near the back. Other investigators imply that this discoloration was caused by dripping solder. As can be seen in later photographs this region of cabinet floor is directly below the drain opening on the sink. Because the garbage disposal and drain had not yet been attached to the sink, burning material from above was able to drop down through the sink drain hole and cause this damage.

Figure 25: Floor of kitchen sink cabinet.

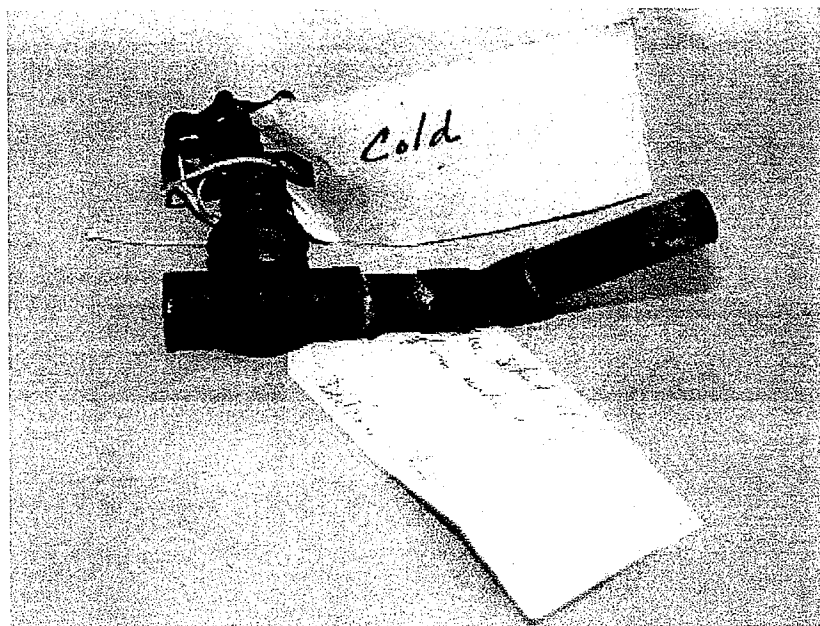
sink was disconnected from the remainder of the pipe. The section of disconnected pipe with a shut-off valve is shown in Figure 32 and Figure 33. To disconnect this section of pipe two soldered joints had to have become disconnected. Mr. Klem concludes that this section of pipe was removed by Mr. Kemp the afternoon before the fire. Mr. Kemp testified that he noticed late in the afternoon before the fire that he would have to move some piping because it would interfere with installation of the garbage disposal but that he decided to wait to do that until the next day and that he did not rotate or move any piping.<sup>21</sup>

Figure 32: Photograph of valve and section of pipe that became disconnected from cold water piping.

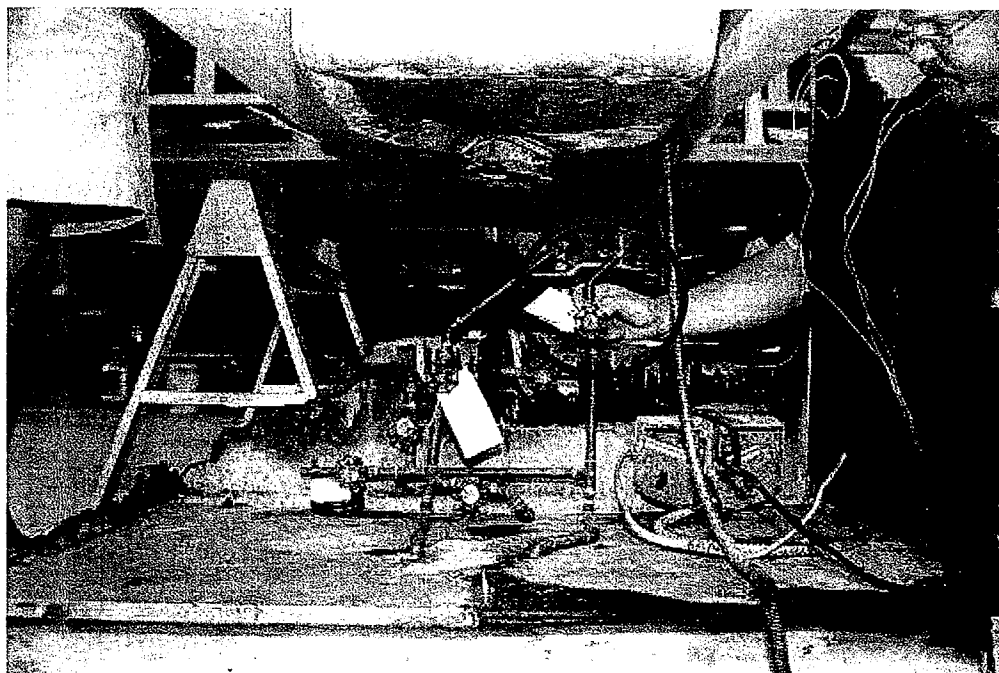
Figure 33: Photograph of disconnected section of valve being held in its original location.

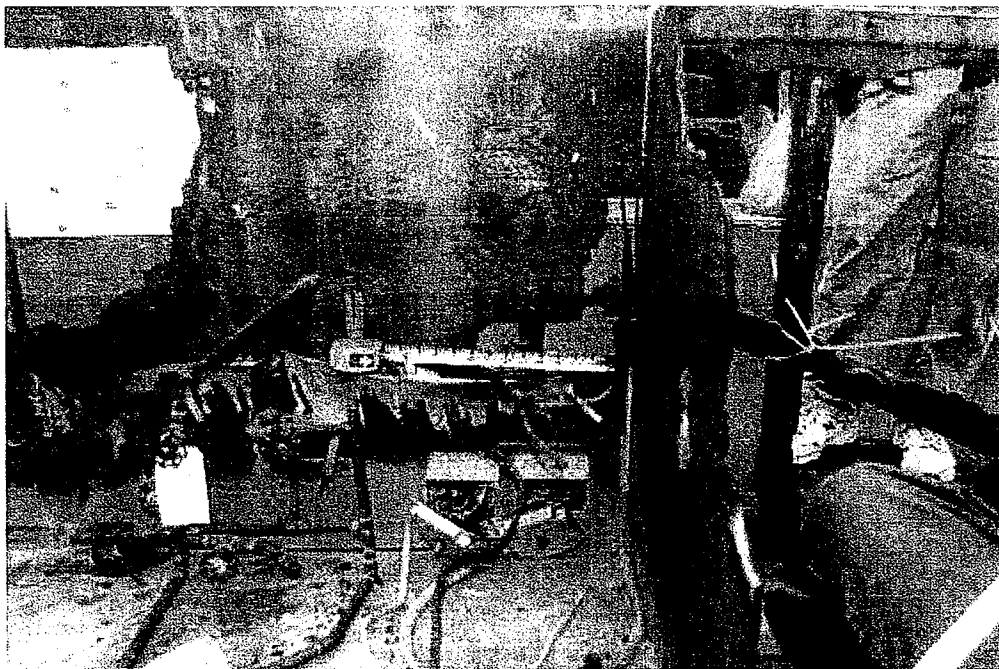
There is a significant distance between where Mr. Kemp is alleged to have used a torch to take apart soldered joints and any portions of the sink cabinet with significant fire damage. As shown in Figure 33 and Figure 34, the location of the portion of pipe that Mr. Kemp allegedly heated with a torch is over 1 foot away from any region of the wall penetration that is significantly burned. Additionally, as shown in Figure 35, exposed plastic vapor barrier remains intact over the portion of this opening that is closest to the water pipe. It is unlikely that an experienced plumber like Mr. Kemp would inadvertently burn portions of the cabinet over 1 foot away from where he was allegedly using the torch.

Figure 34: Photograph showing distance of water pipe from penetration in wall.

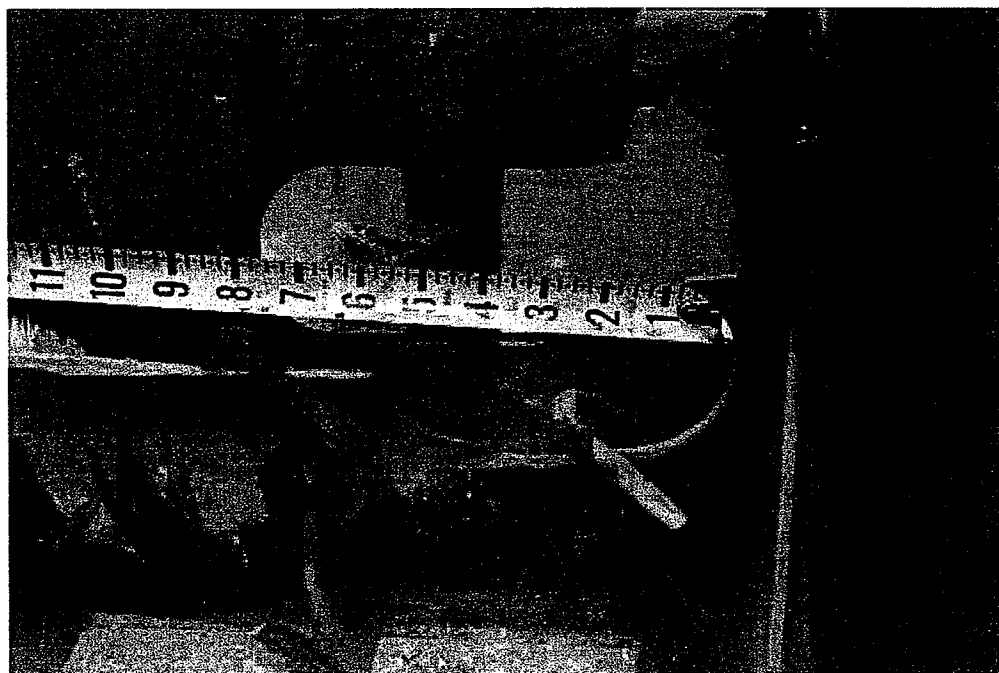
Figure 35: Photograph showing penetration in wall.
